**Flood Control Project Maintenance
Levee Inspections**

Maintenance Issue Types Only, Levee Inspection Report By Mile - Spring 2018

Sacramento Maintenance Yard Sacramento Bypass

Waterway	Bank	Unit Miles	Inspection Start/End	Inspector
Unit No. 01 Sacramento Bypass or North Levee	Right	1.74	04/17/2018 04/17/2018	Zach Jojola

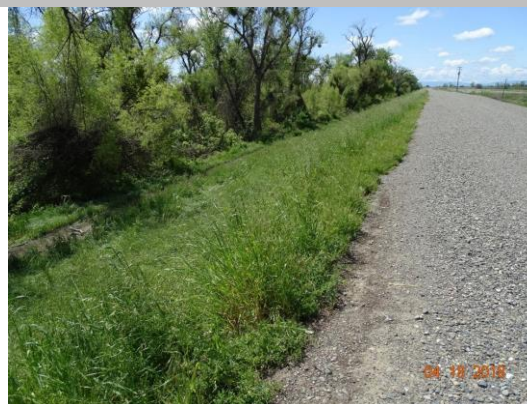
Photo 1 of 1 : SP_2018_ST0008_284_7_20180419_00021.jpg

LM Start	0.40	Rating **	U	Issue No.	7
LM End	1.73	Issue Type +	Ma	Location *	WS
Category	Earthen Levee		GPS Latitude/Longitude		
			Start	End	
Item	Vegetation		38.605010 °	38.599469 °	
			-121.566808 °	-121.590155 °	
DWR ID	DWR_ST0008_01_s_2018_7				
Comment Code					
V1 : Control annual grass and weeds on the levee slopes and easements.					
Inspector Comment

View of vegetation on the waterside slope. Spring 2018.

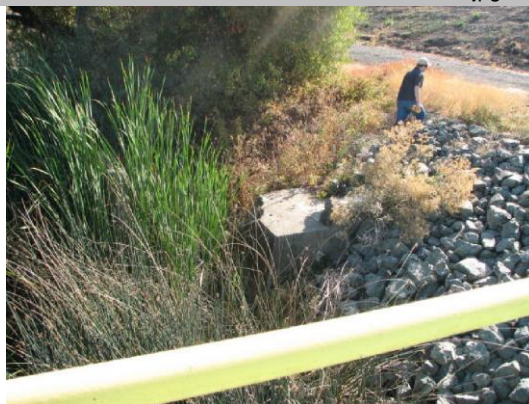
Photo 1 of 3 : UCIP_SP_2018_44787_20605.jpg

LM Start	1.09	Rating **	A/W	Issue No.	16	
LM End	1.09	Issue Type +	Ma	Location *		
Category	Supplemental			GPS Latitude/Longitude		
				Start		End
Item	DWR UCIP LMA Responsibility			38.602169 °		38.602169 °
				-121.579000 °		-121.579000 °
DWR ID						
Comment Code						
Inspector Comment						
FS_ID:44787						
DS_ID:19076						
EP_NO: N/A						
Repair Type: No Action Needed						
Crossing Status: Found						
UCIP Comments: A concrete saddle found on slough/drainage. No pump was found on LS and no structure/pipe found on WS.						
FIELD_STRUCT_DESC: *ABANDONED* 36-inch corrugated metal drainage pipe through the levee, at an unknown depth. Grouted in place. Remains of concrete structure found on the landside (LS).						
[Additional Reference(s): USACE Sacramento O&M Manual 122.1, August 1955, (RM 174)].						
FS Date: 4/28/2015 2:44:05 PM

Landside view: overview

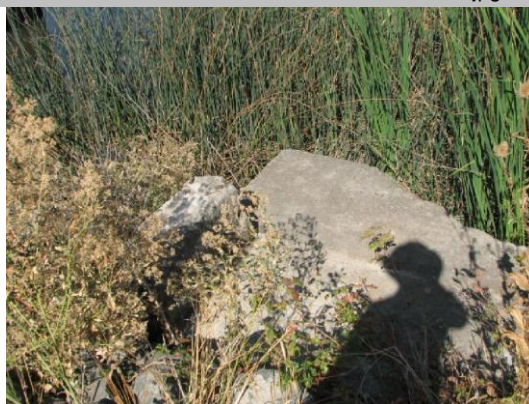
Photo 2 of 3 : UCIP_SP_2018_44787_20604.jpg

Landside view: remaining of concrete structure

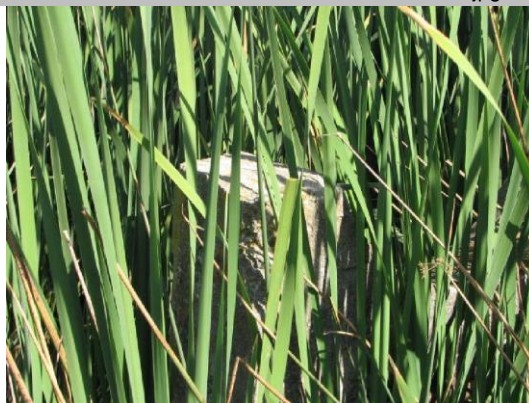
Photo 3 of 3 : UCIP_SP_2018_44787_20606.jpg

LM Start	1.09	Rating **	A/W	Issue No.	16 (cont)
LM End	1.09	Issue Type +	Ma	Location *	
Category	Supplemental			GPS Latitude/Longitude	
				Start	End
Item	DWR UCIP LMA Responsibility			38.602169 °	38.602169 °
				-121.579000 °	-121.579000 °
DWR ID					
Comment Code					
Inspector Comment					
FS_ID:44787 DS_ID:19076 EP_NO: N/A Repair Type: No Action Needed Crossing Status: Found UCIP Comments: A concrete saddle found on slough/drainage. No pump was found on LS and no structure/pipe found on WS. FIELD_STRUCT_DESC: *ABANDONED* 36-inch corrugated metal drainage pipe through the levee, at an unknown depth. Grouted in place. Remains of concrete structure found on the landside (LS). [Additional Reference(s): USACE Sacramento O&M Manual 122.1, August 1955, (RM 174)]. FS Date: 4/28/2015 2:44:05 PM

Landside view: remaining of concrete structure on drainage/slough

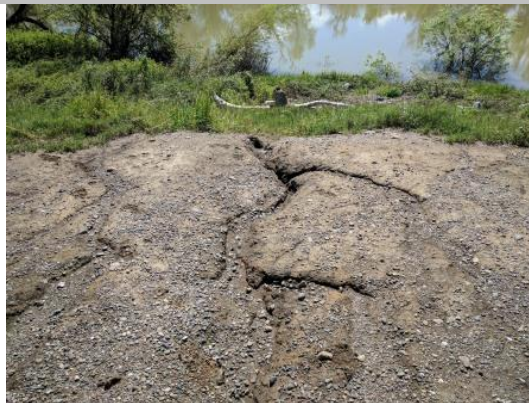
Photo 1 of 1 : SP_2018_ST0008_284_15_20180306_00011.jpg

LM Start	1.74	Rating **	A/W	Issue No.	15
LM End	1.74	Issue Type +	Ma	Location *	WS
Category	Earthen Levee			GPS Latitude/Longitude	
				Start	End
Item	Erosion / Bank Caving			38.599546 °	38.599546 °
				-121.590235 °	-121.590235 °
DWR ID	DWR_ST0008_01_s_2018_15				
Comment Code					
E1 : Note and monitor erosion site.					
Inspector Comment					
Runoff erosion on oversized levee section. Lcoated on waterside levee slope. Recommend monitoring.

View of erosion on waterside slope. Spring 2017.

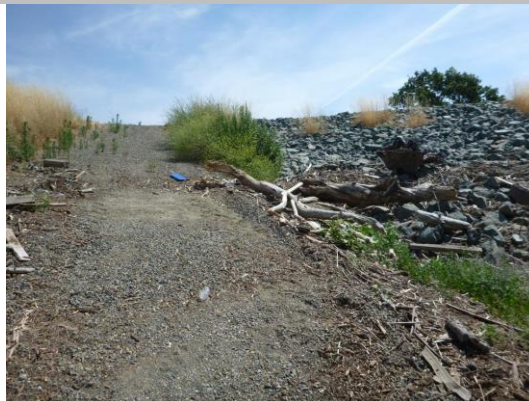
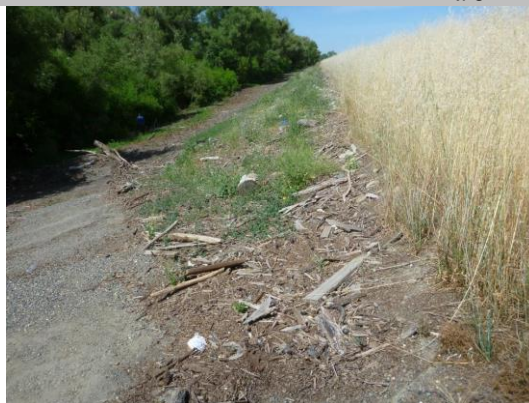
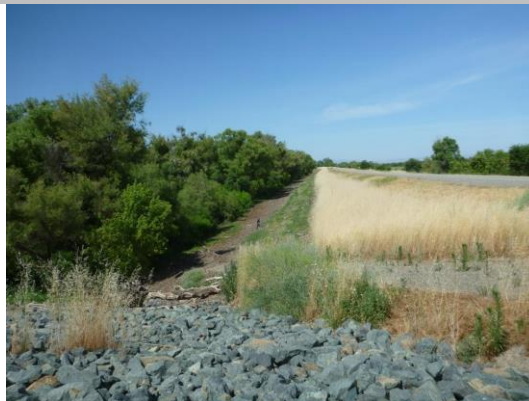
Notes: Minor wavewash on landside levee slope; no active erosion; no cross section taken, photo only. No visible damage observed during fall inspection.

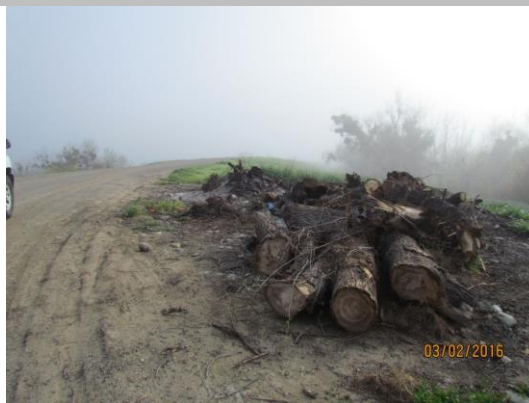
Photo 2 of 2 : SP_2018_ST0008_285_5_20180306_00010.jpg

LM Start	1.77	Rating **	A/W	Issue No.	5 (cont)	
LM End	1.77	Issue Type +	Ma	Location *	LS	
Category	Earthen Levee			GPS Latitude/Longitude		
				Start		End
Item	Encroachments			38.594743 °		38.594743 °
				-121.586556 °		-121.586556 °
DWR ID	DWR_ST0008_02_s_2016_5					
Comment Code						
PR : Prunings						
Inspector Comment						
This is a seasonal pile but gets burned by the LMA each year.

View of the firewood on the landward side of the levee looking upstream. Spring 2016.

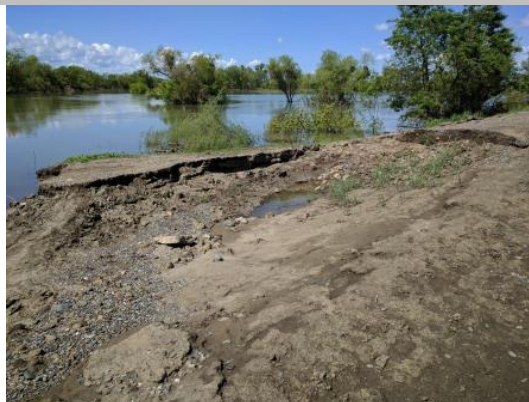
Photo 1 of 1 : SP_2018_ST0008_285_8_20180306_00012.jpg

LM Start	1.77	Rating **	A/W	Issue No.	8
LM End	1.77	Issue Type +	Ma	Location *	WS
Category	Earthen Levee			GPS Latitude/Longitude	
				Start	End
Item	Erosion / Bank Caving			38.594710 °	38.594710 °
				-121.586582 °	-121.586582 °
DWR ID	DWR_ST0008_02_s_2017_8				
Comment Code					
E1 : Note and monitor erosion site.					
Inspector Comment					
Runoff location, but not within the levee prism. Recommend monitoring.

View of erosion on waterside levee slope. Spring 2017.
